WATER OPERATION AND MAINTENANCE

BULLETIN NO. 134

December 1985

THE EQUALIZATION OF STRAWBERRY AND SOLDIER CREEK RESERVOIRS BONNEVILLE UNIT CENTRAL UTAH PROJECT

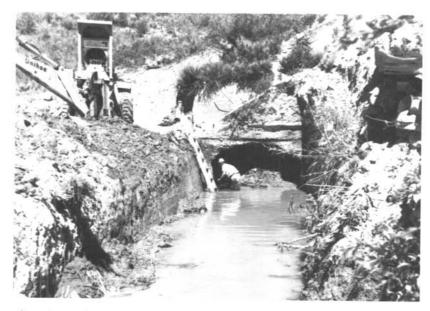
During World War II the outlet portal of the sluicing tunnel was covered with soil to prevent unauthorized entry. This earth cover was removed on July 15, 1974, so that an inspection team could enter the tunnel. The inspection report stated that the downstream face of the sluice gates and the tunnel downstream from the gates were in "remarkable condition". The portal was again covered with earth after the inspection for safety reasons.

Removing earth cover at the Strawberry Dam sluice tunnel outlet portal for inspection of the sluice gates.

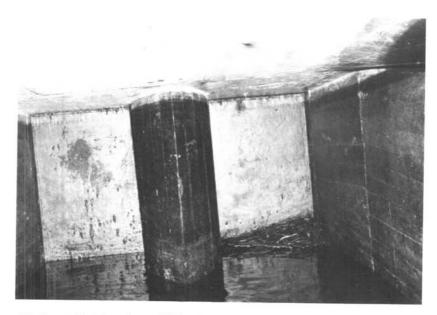
North gate (right), south gate (left), and divider as seen from downstream after water had been drained from tunnel.

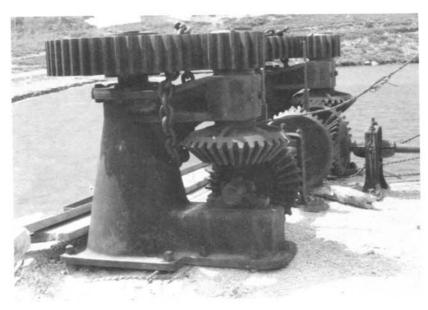
The concrete supporting the original hoisting mechanism had spalls up to 2 inches deep and was not considered capable of bearing the loads necessary to raise the gates. The original hoists were dismantled and the weathered concrete removed. Steel reinforced concrete 4 inches thick was then placed on the prepared surface. Steel plate 1/2-inch thick was embedded in the new concrete to level the area around the gate stems.

Original Strawberry Dam sluice gates hoisting mechanism. Note square twisted rebar protruding from weathered concrete.

Steel bearing frames were constructed to transfer the load from each cylinder to the concrete at an allowable stress. The bearing frames also provided space to secure the gate stem while the cylinder plunger was lowered during each lift cycle. The frames were constructed of 3/4-inch steel plate and W6 x 25 wide-flange steel sections. The steel plate was sized in the same manner as steel column base plates (American Institute of Steel Construction, design procedure).

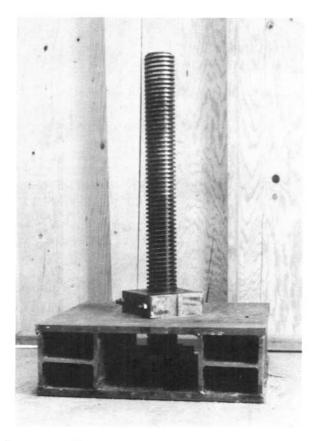
Steel bearing frame centered on 3-1/2-inch diameter threaded bronze gate stem. The lower split nut held the gate stem while the hydraulic cylinder and the upper split nut were lowered.

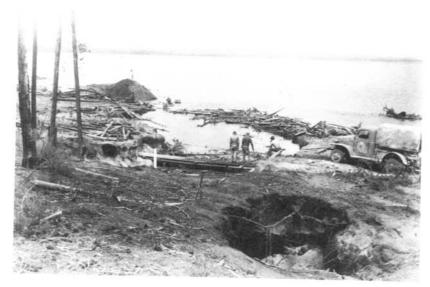
<u>Evidence</u>: Three large sinkholes appeared in the reservoir several miles southeast of the dam and later along a fault line near the dam in 1948. Considerable seepage up to 40 ft³/s was observed downstream of the East Wickiup Dike and resulted in die-off of native forest and vegetation. Recorded downstream seepage was known to vary in direct proportion to the reservoir elevation. Seepage into other large sinkholes located southeast of the dam near the reservoir rim was estimated at 350 ft³/s and the outlet or subsurface course of this seepage is unknown. One explored sinkhole was about 60 feet deep and extended an unknown distance beyond.

<u>Causes</u>: The cause of the seepage can be traced to local geologic conditions. The reservoir basin is underlain at depth by lava flows covered with a considerable thickness of sedimentary deposits but both were found to be cut by young faults. Because the young faults have disturbed the sedimentary deposits and volcanic rocks, the sediments do not form an adequate seal over the entire reservoir floor. The postconstruction surface expressions of the faults have occurred as a result of erosion of the surface formations by wave action and seepage of the reservoir.

THE BIG LEAK AT BASE OF DAVIS MOUNTAIN 5-27-48-Bureau of Reclamation photo by R.A. Baker.

Picture was taken on hillside a few feet above and possibly 35 feet back from the designed reservoir flow line, looking slightly east of north. Dark-colored mountain at upper right is Round Mountain. Water surface is at elevation 4328.0 or 4.2 feet below designed flow line. An estimated 350 second-feet of water is flowing past boat toward footbridge where most of the water disappears. Collar of sinkhole in right foreground is nearly 4 feet above and possibly 50 feet back from highest shoreline reached that year. The sinkhole is due to the removal of the underlying clayey silt and pumice by the escaping water. A crooked crack trending southward was found in the pumice soil near trees at left, and another one was seen south of the sinkhole. An earthen dike, being constructed to stop the leakage into this channel, is shown in upper left part of picture, possibly 160 feet north from the sinkhole. Several vertical-sided holes were observed in the reservoir floor north of the dike, but they did not appear to be taking much water on the day this picture was taken.

<u>Remedy</u>: The reservoir was visually surveyed by jeep and airplane to identify and map any other existing or potential sinkholes. Later, and in order to reduce the seepage, identified sinkhole crevices were sluiced, backfilled, and compacted with material similar to that used for earth embankments. A 3-mile collection channel was excavated downstream of the dam to collect surface seepage and lower the water table.

At the present time (1985), the reservoir is routinely inspected for new sinkholes or changes in old sinkholes. Loss due to seepage continues, but at an acceptably reduced rate.
